FINAL REPORT OF PHASE II

HIGH SHOCK FM TRANSMITTER

CONTRACT NUMBER NAS1-5042

14 MAY 1966

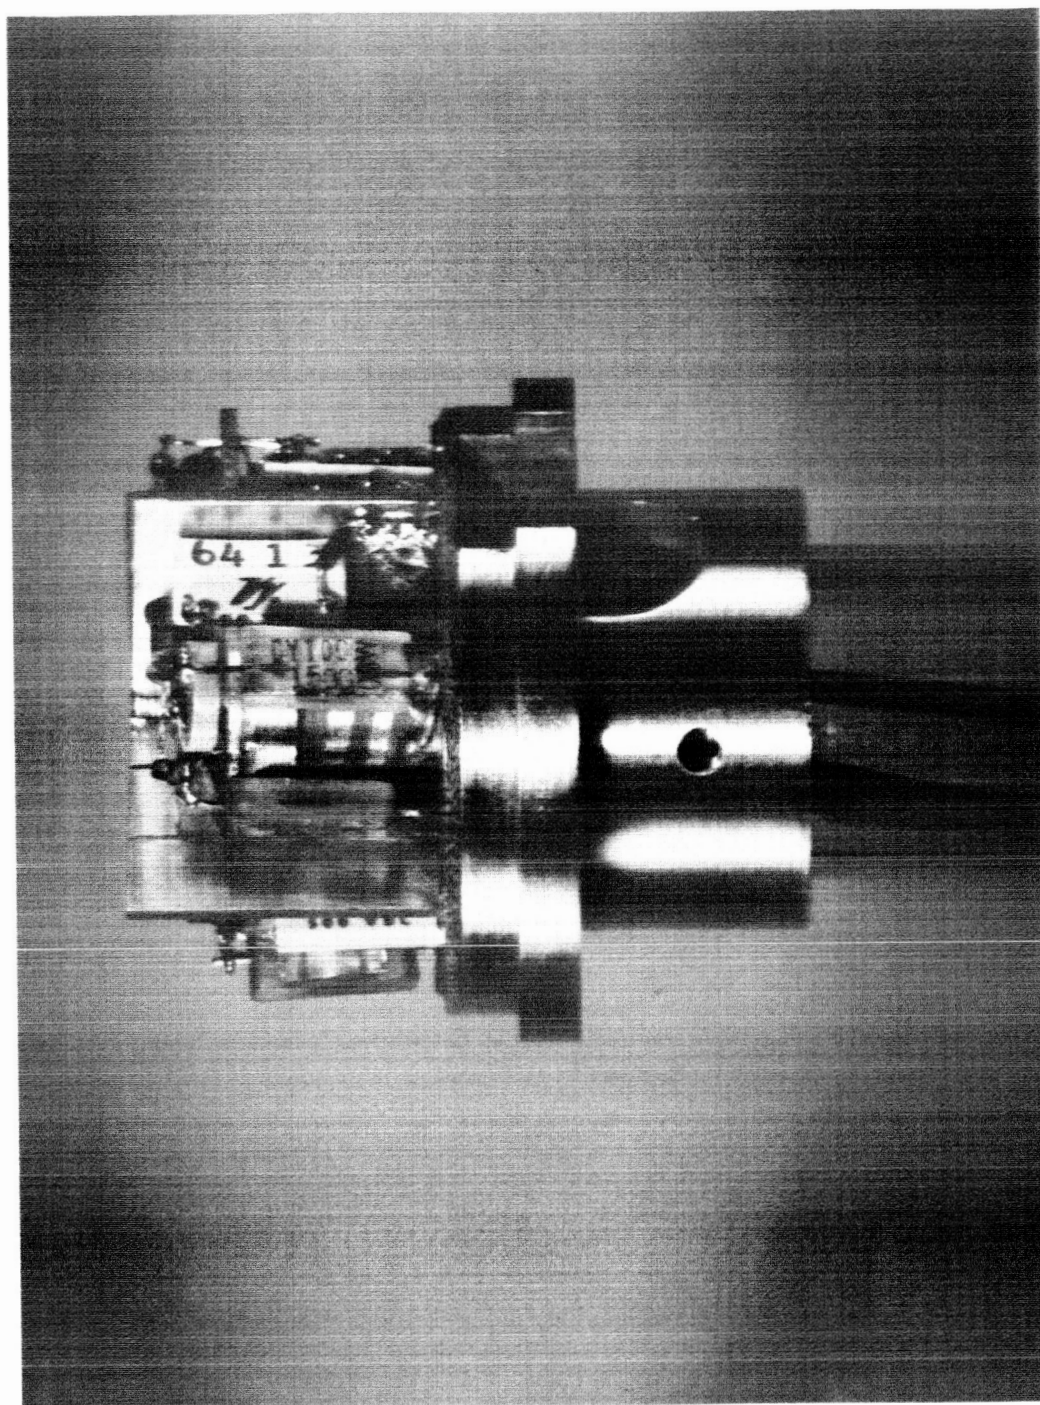
Figure 17. Photograph Showing Power Amplifier of Unpotted Transmitter

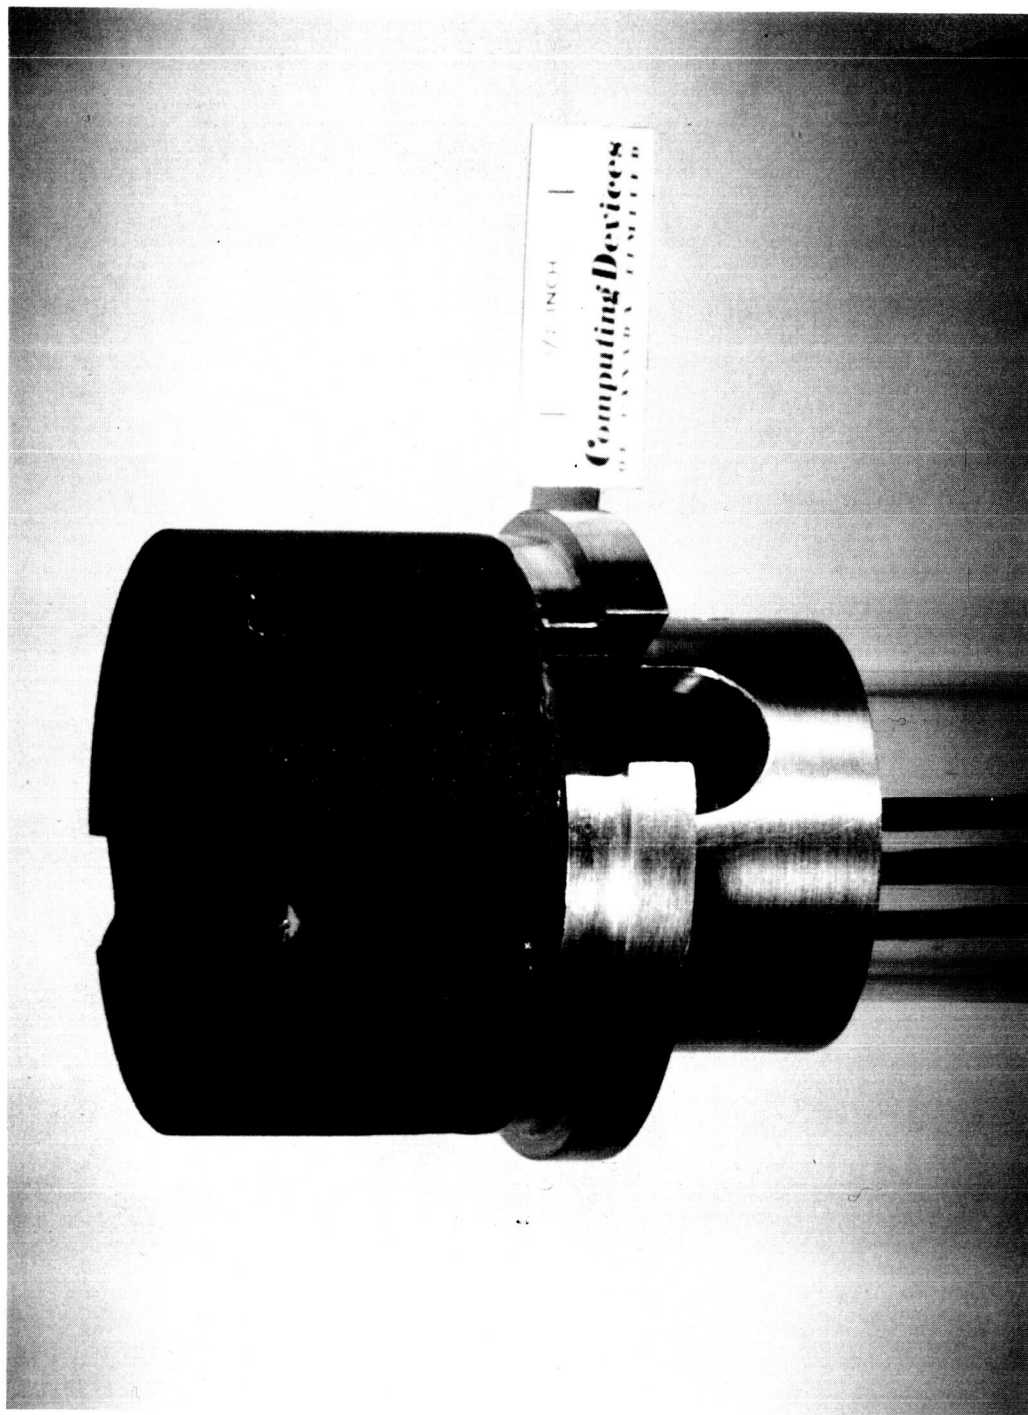
Figure 18. Photograph Showing Transmitter Module After First Potting

4 To minimize these effects potting must be carried out in a series of steps. The first encapsulates all the components except the tuning capacitors in each stage and the modulation sensitivity resistor. Figure 18 shows the transmitter after the initial potting. The small cavities in the walls are for the tuning capacitors which will be added and potted in two further steps. First the oscillator and power amplifier and after readjustment for maximum transmitter performance, the 1st and 2nd amplifier tuning capacitors. The modulation sensitivity resistor is potted last.

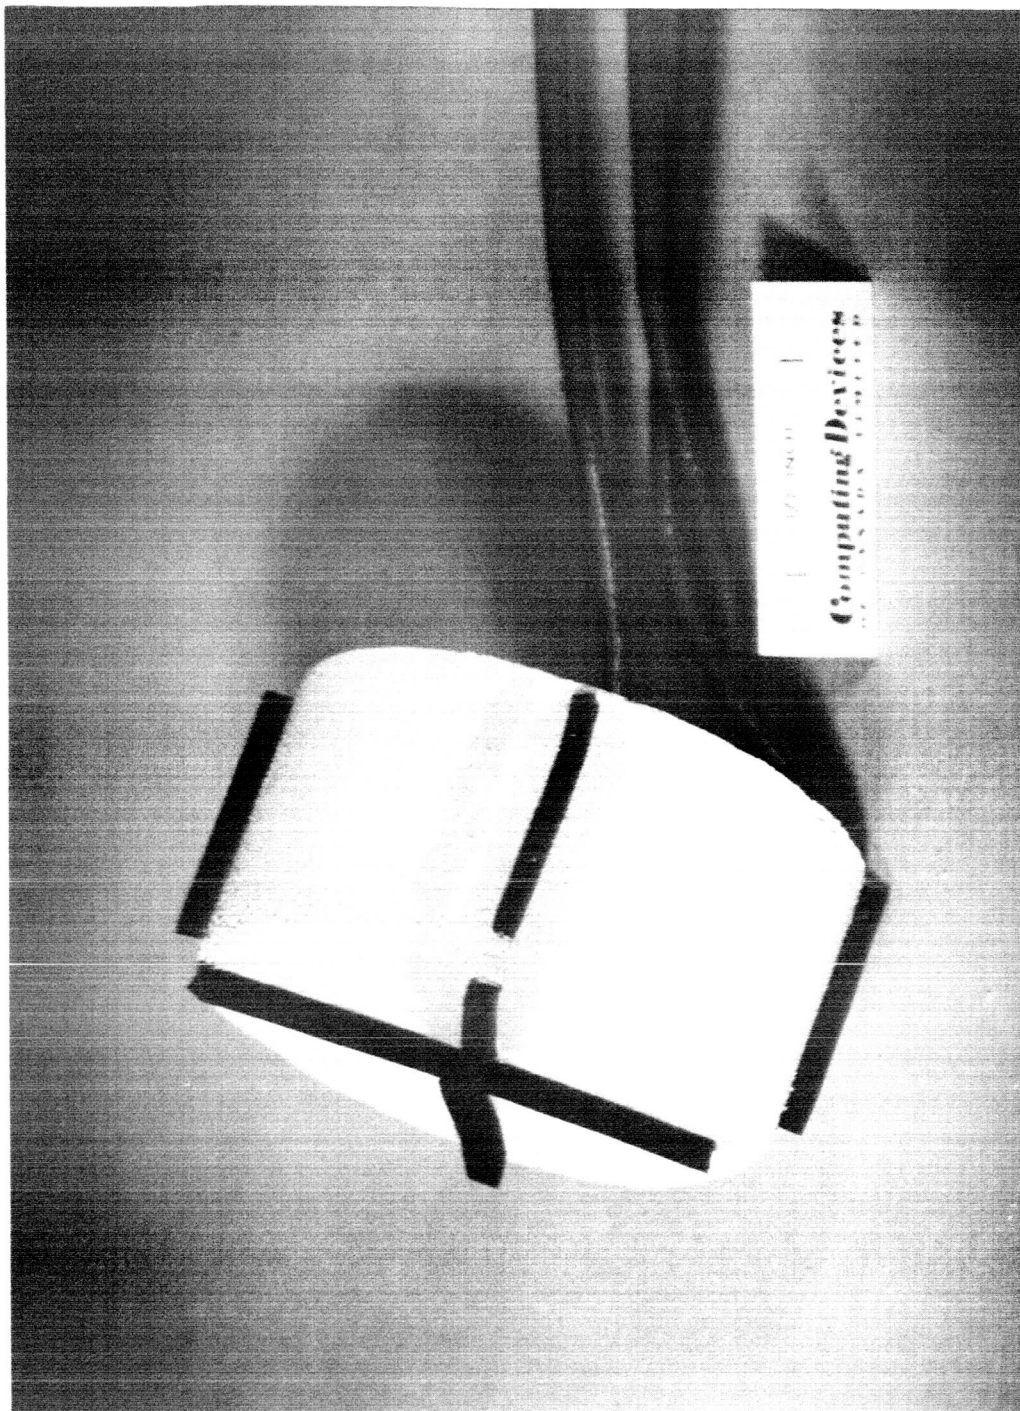
Figure 19. Photograph Showing Transmitter Module with Silver R.F. Shield
and Rubber Spacers

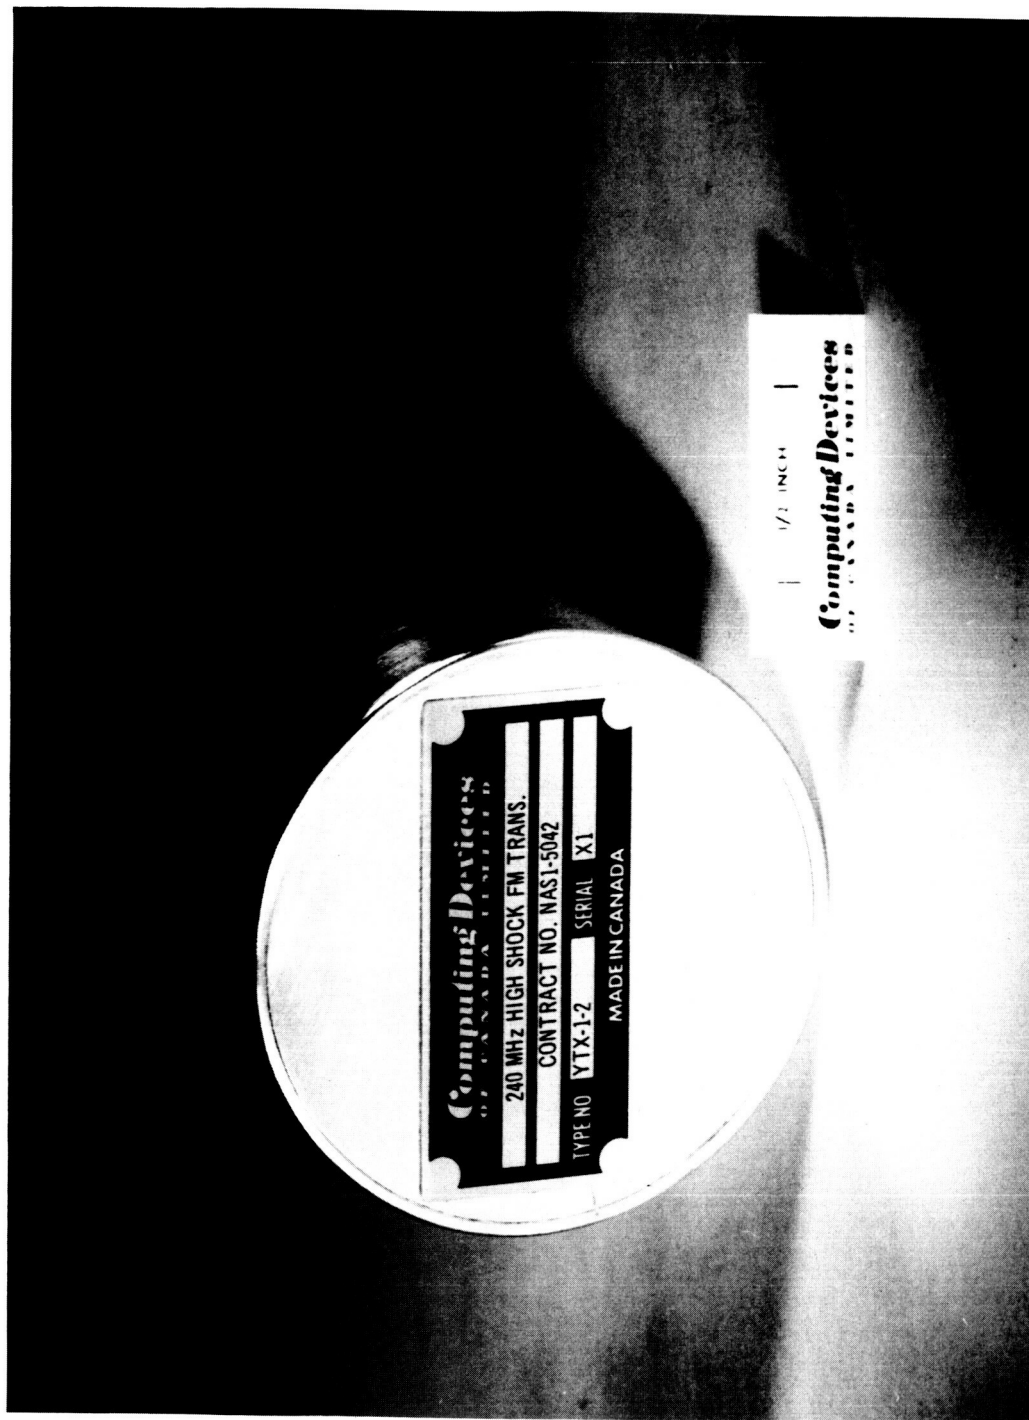
Figure 20. Photograph Showing Final Transmitter YTX-1-2

5 After potting, the r.f. shield is applied to the outer surface of the transmitter module as described in Section 2. The module is then potted into the outer aluminum case with silastic rubber, using narrow 1/16 inch rubber strips glued to the r.f. shield, as spacers to maintain the necessary distance between the module and the outer case. These spacers attached to the r.f. shield are shown in Figure 19. The completed transmitter YTX-1-2 is shown in Figure 20.

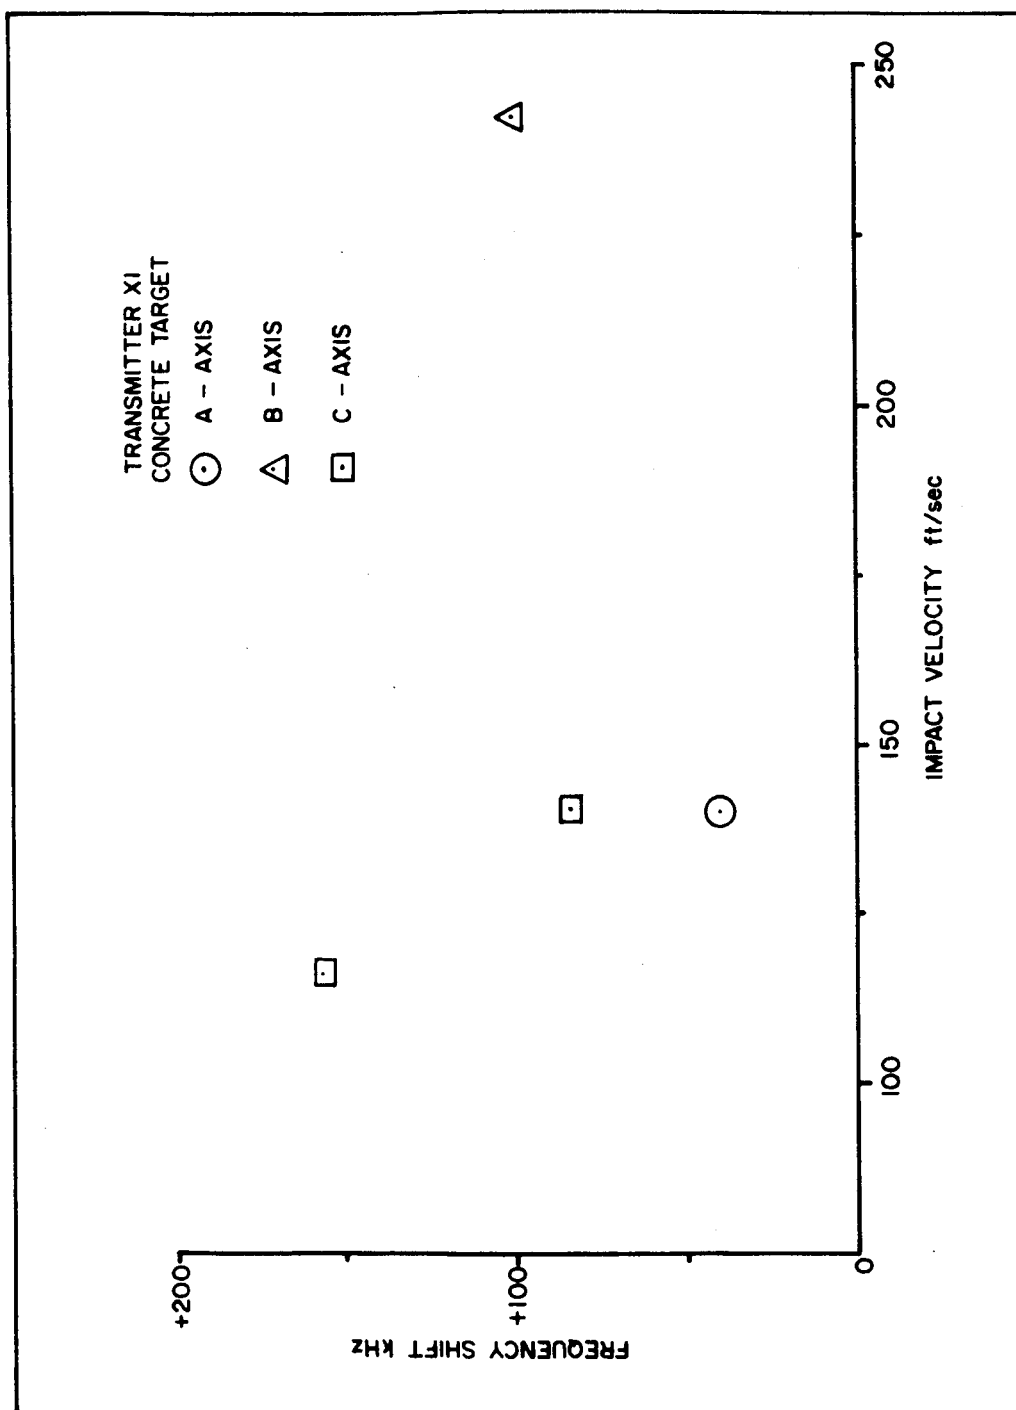
Figure 22. Impact Test Results, Transmitter X1

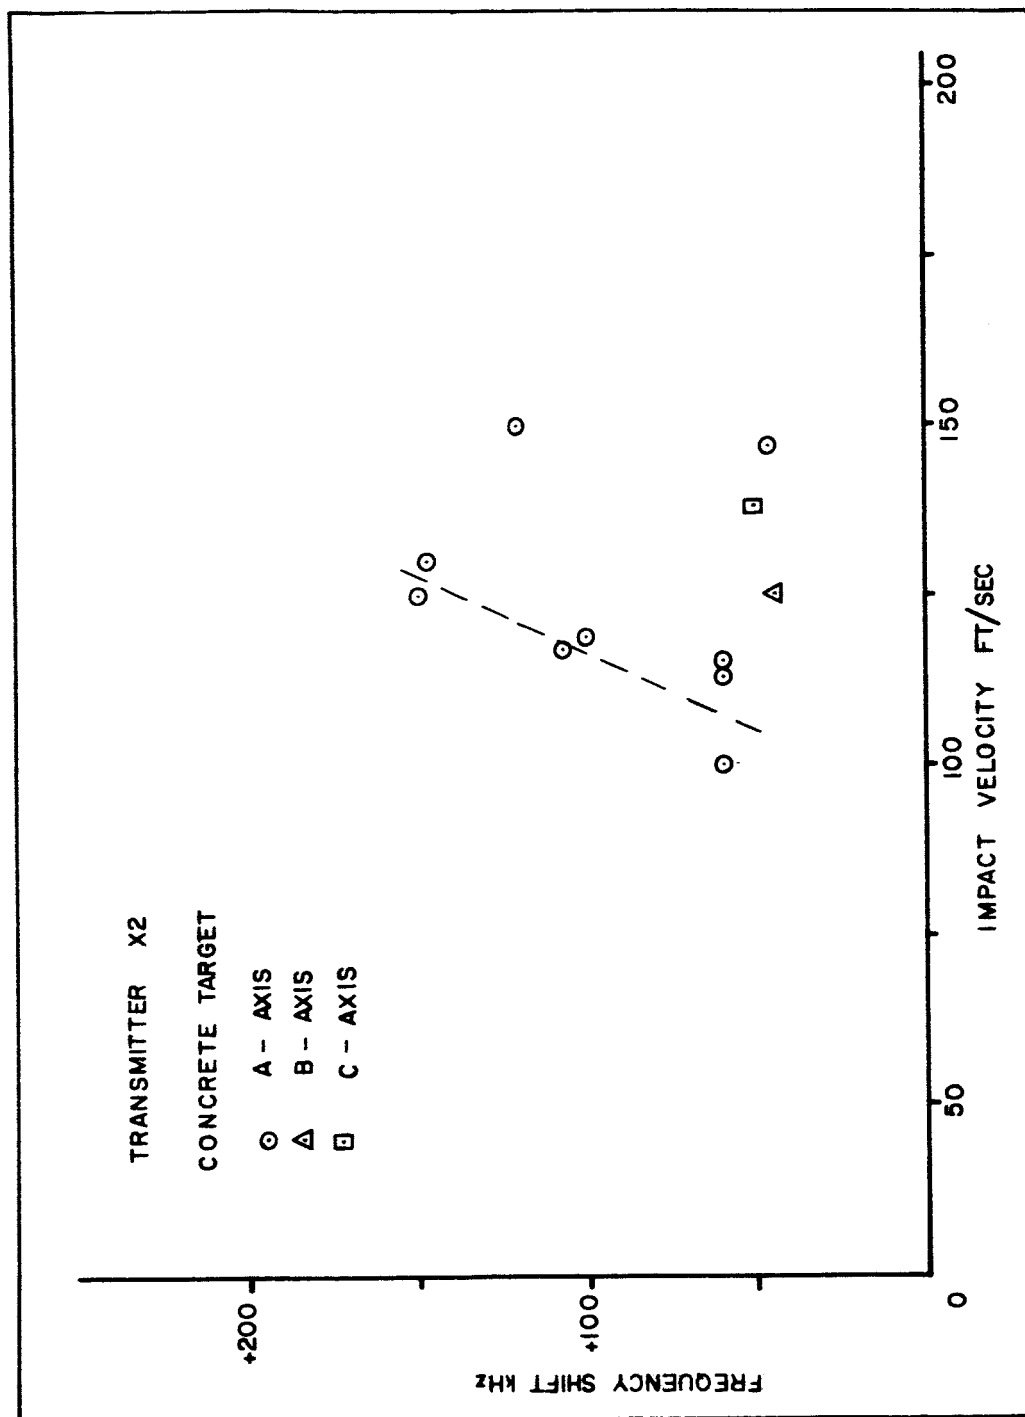
Figure 23. Impact Test Results, Transmitter X2

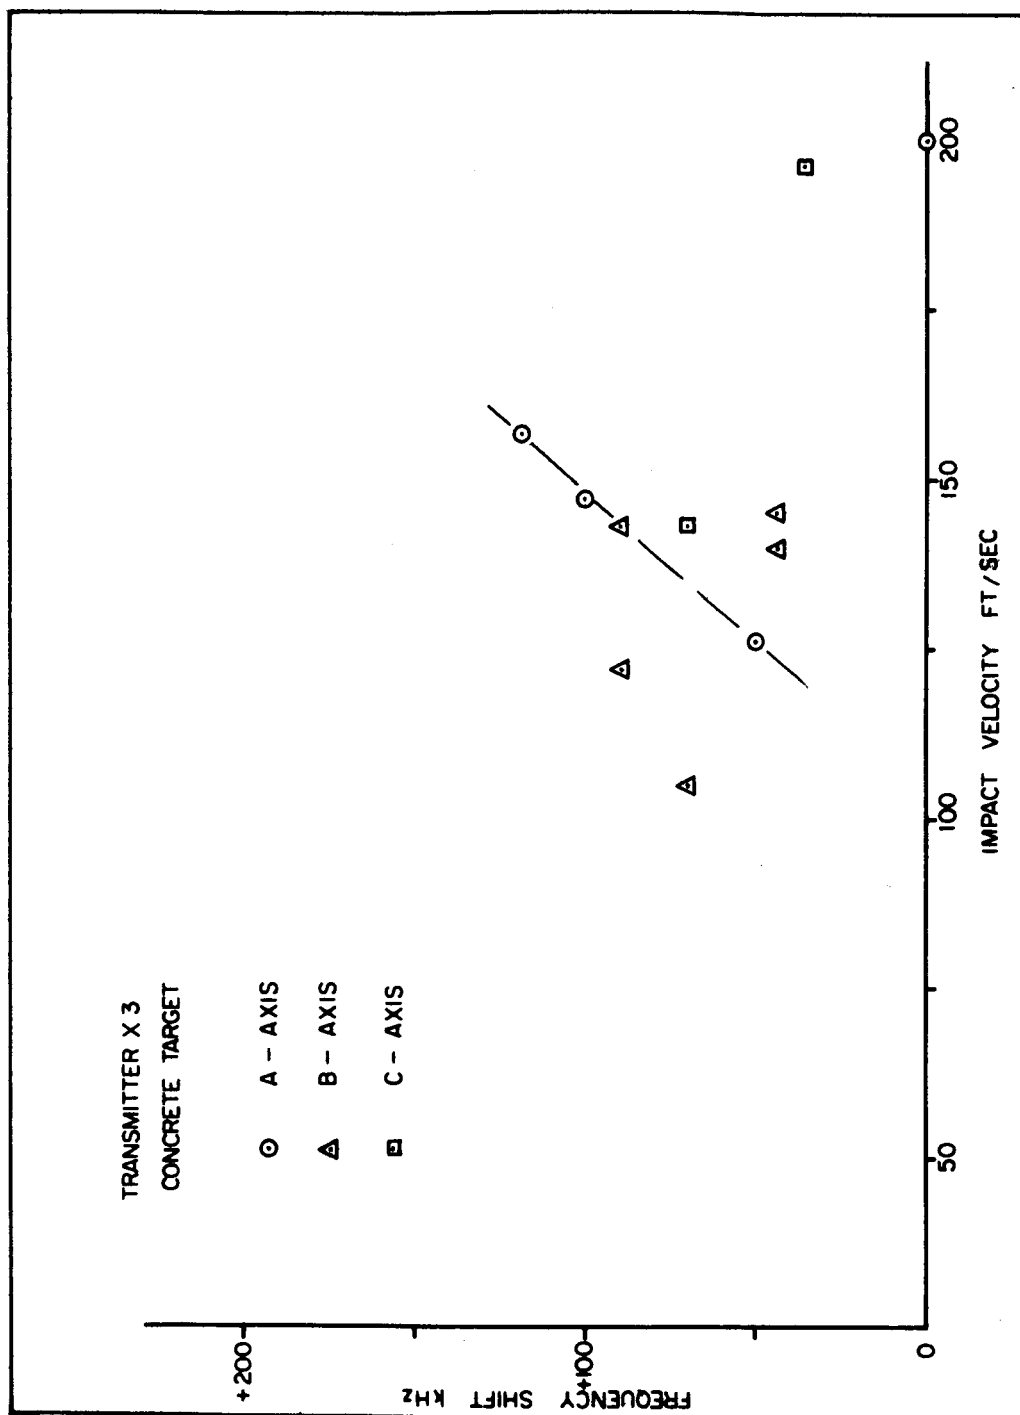
Figure 24. Impact Test Results, Transmitter X3

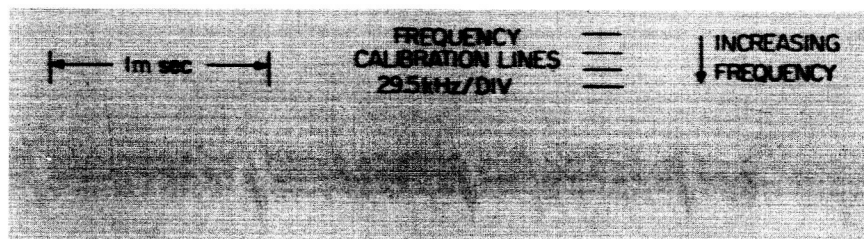
Figure 25. Selected Records Showing Transmitter Frequency Change during Impact

2 Examination of Figure 25 and Table 3 indicates a definite similarity in the impact pulses for transmitter X3. The frequency increases rapidly for approximately 0.075 millisecond, decays more slowly for approximately 0.25 millisecond and then goes negative for approximately 0.2 millisecond. The two results for transmitter X2 show a slightly different pulse with only a positive frequency change. The reason for the negative change has not been clearly established but it is surmized that it is due to the relaxation of the plastic after impact. The pulse time for all the transmitters appears to be approximately 0.3 millisecond. The positive change has been assumed the more important frequency shift, since the negative one appears to occur after the ball has left the target.

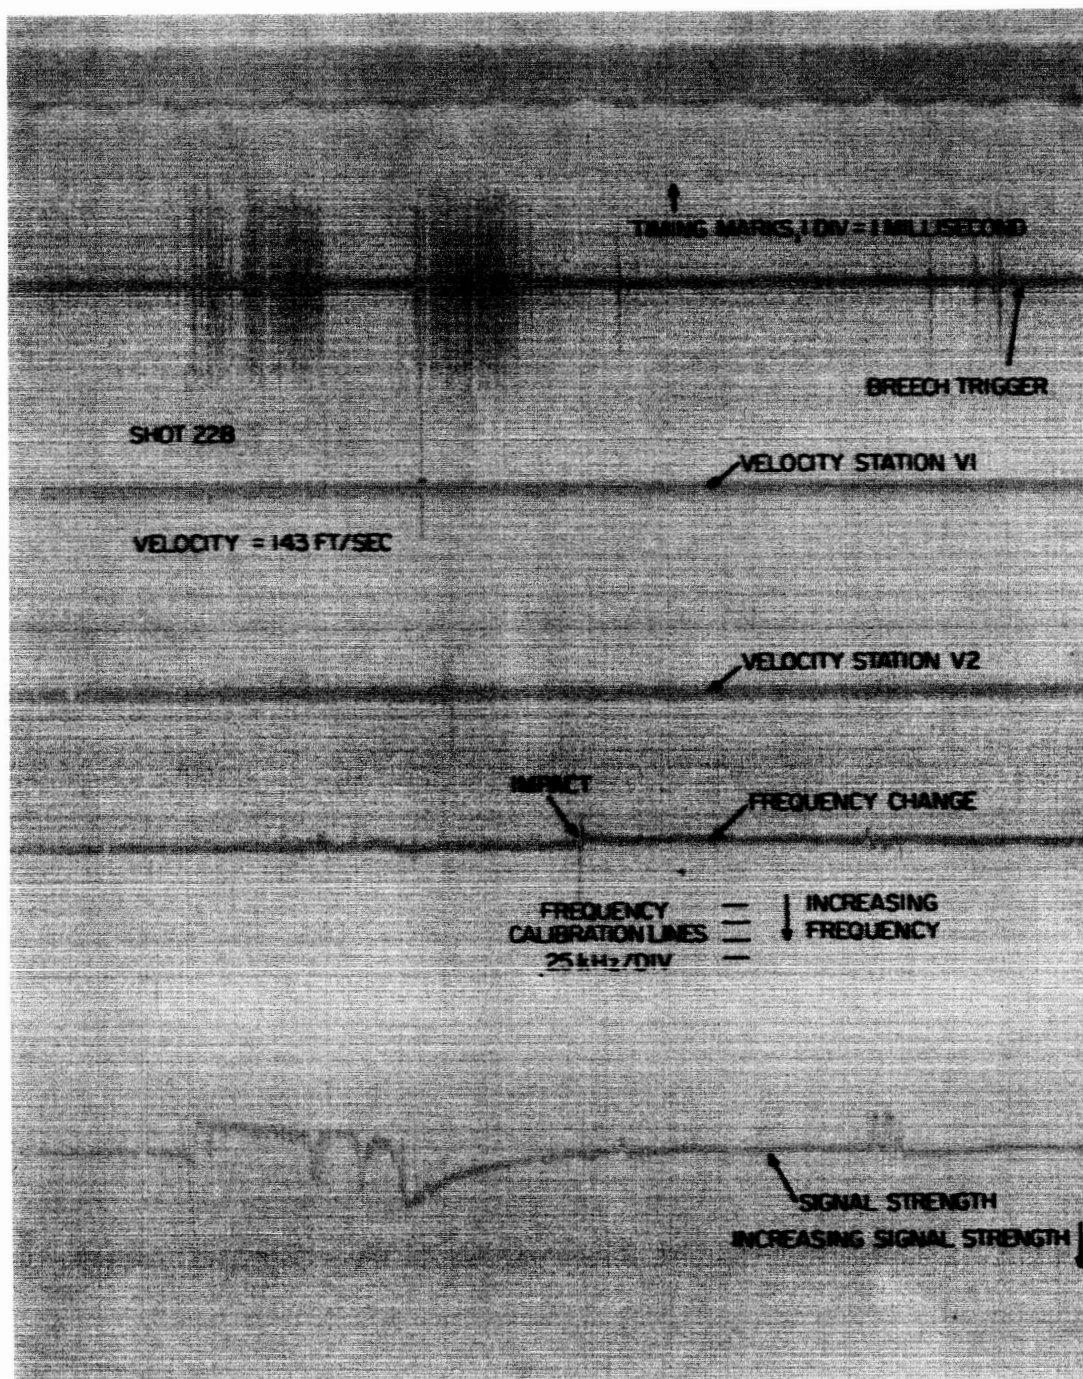
Figure 26. Typical Impact Firing Record, Shot No. 228

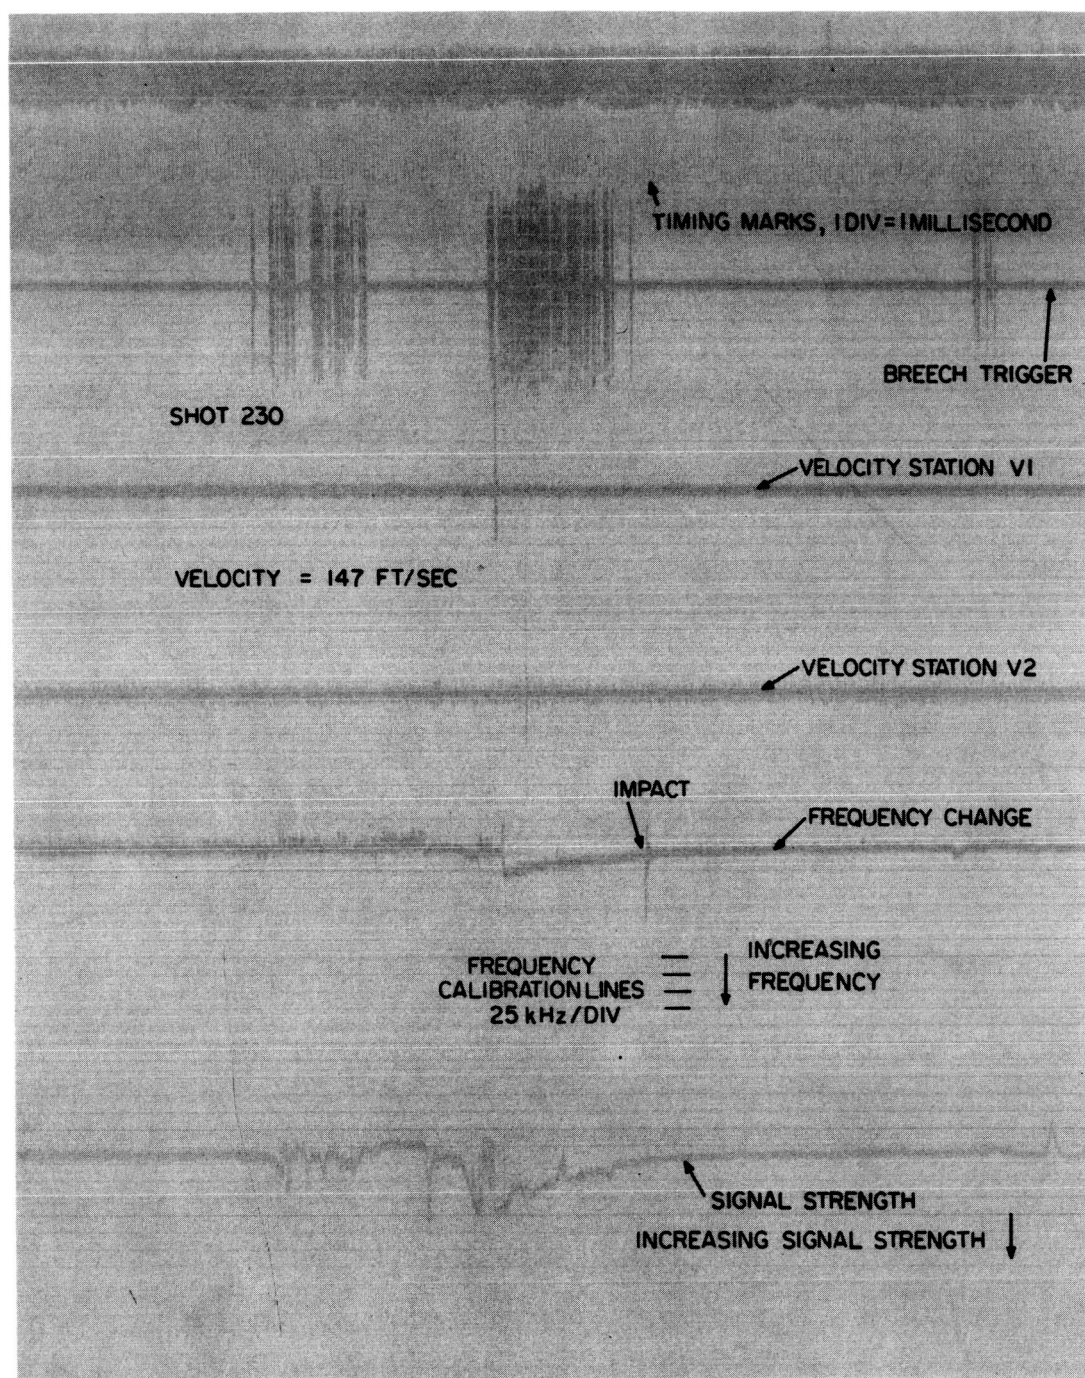
Figure 27. Typical Impact Firing Record, Shot No. 230

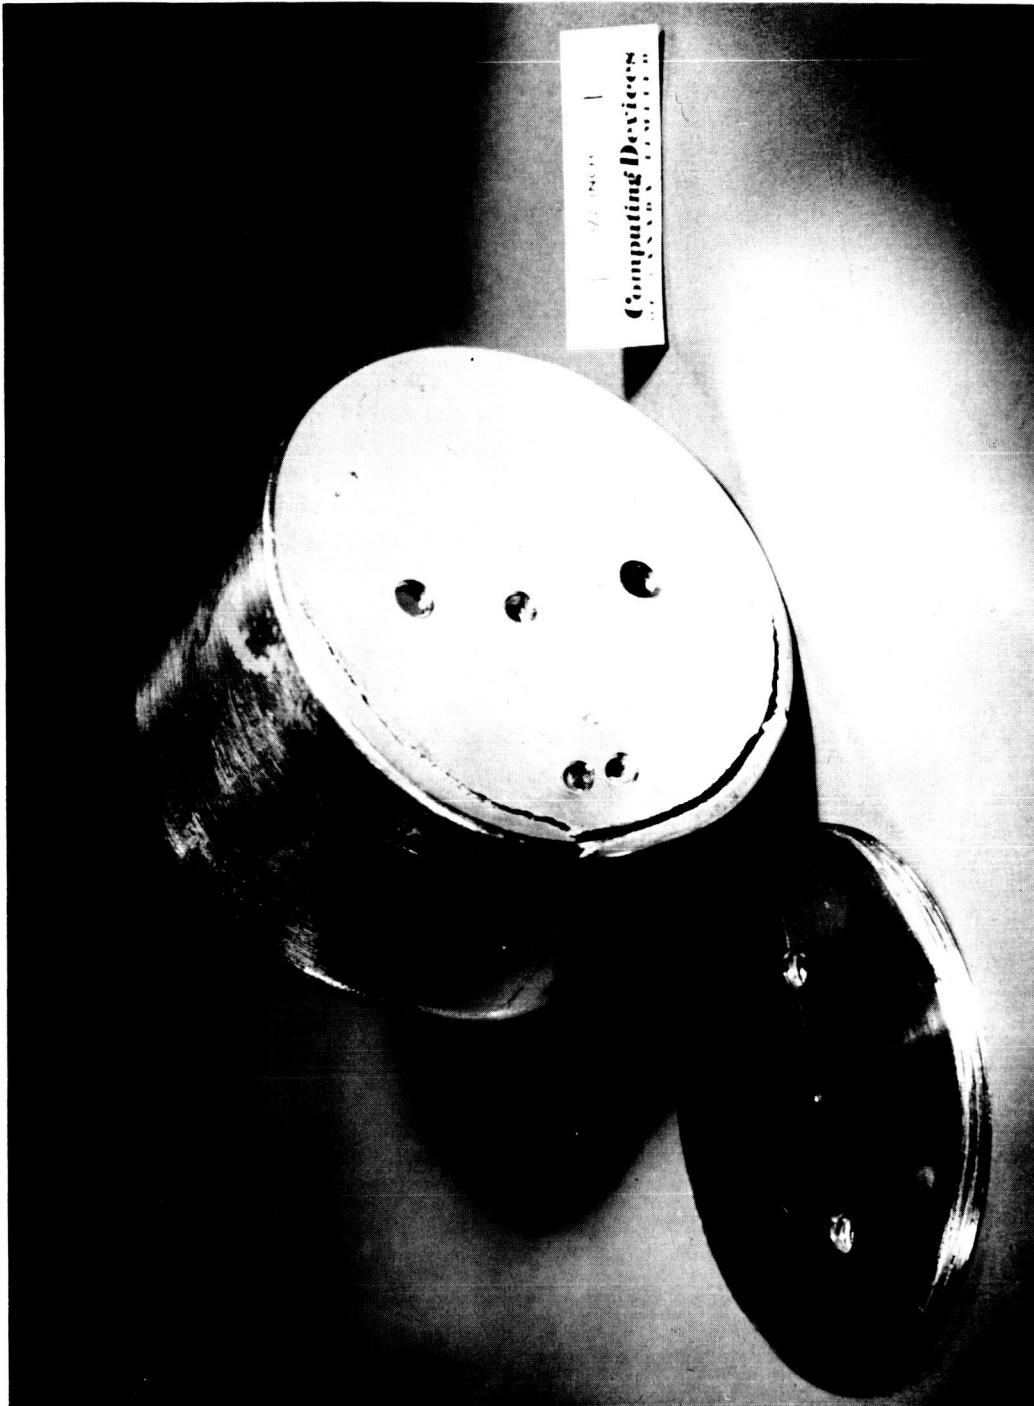
Figure 28. Photograph Showing Case of Transmitter X1 after Impact Tests

14 Transmitter X1 failed after eight shots below 150 and three shots above 220 feet per second. Figure 28 shows the case of X1 after removal from its test ball. Less damage occurred to the cases of X2 and X3. Calculations based on the Hertz contact laws show that for an impact duration of 0.3 millisecond and a velocity of 140 feet per second the peak acceleration experienced by the ball would be in the order of 130,000 g's, at 240 feet per second the value is 246,000 g's.

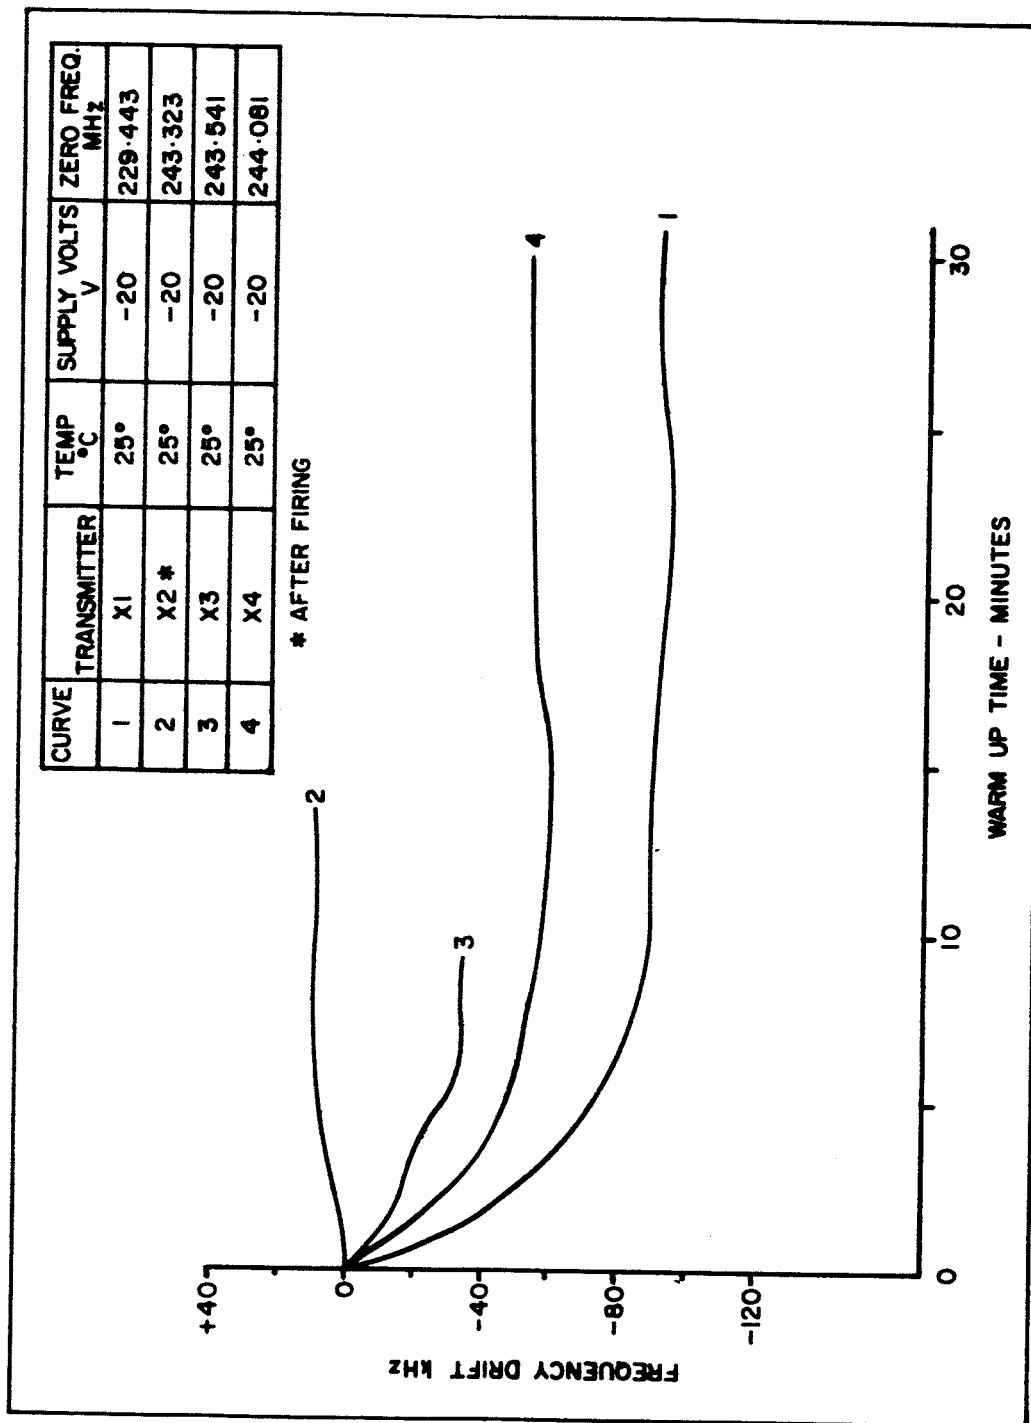
Figure 29. Transmitter Warm Up Times and Short Term Stability

Transmitter X2 shows good warm up under all supply voltages and constant case temperature conditions. The warm up of X2 in the epoxy ball at ambient temperature is shown in Figure 29 as curve 5. The warm up time and short term stability are well within those specified in Appendix A. The short term stability for all transmitters is well within the specified ± 0.004 per cent over and five minute period after warm up.

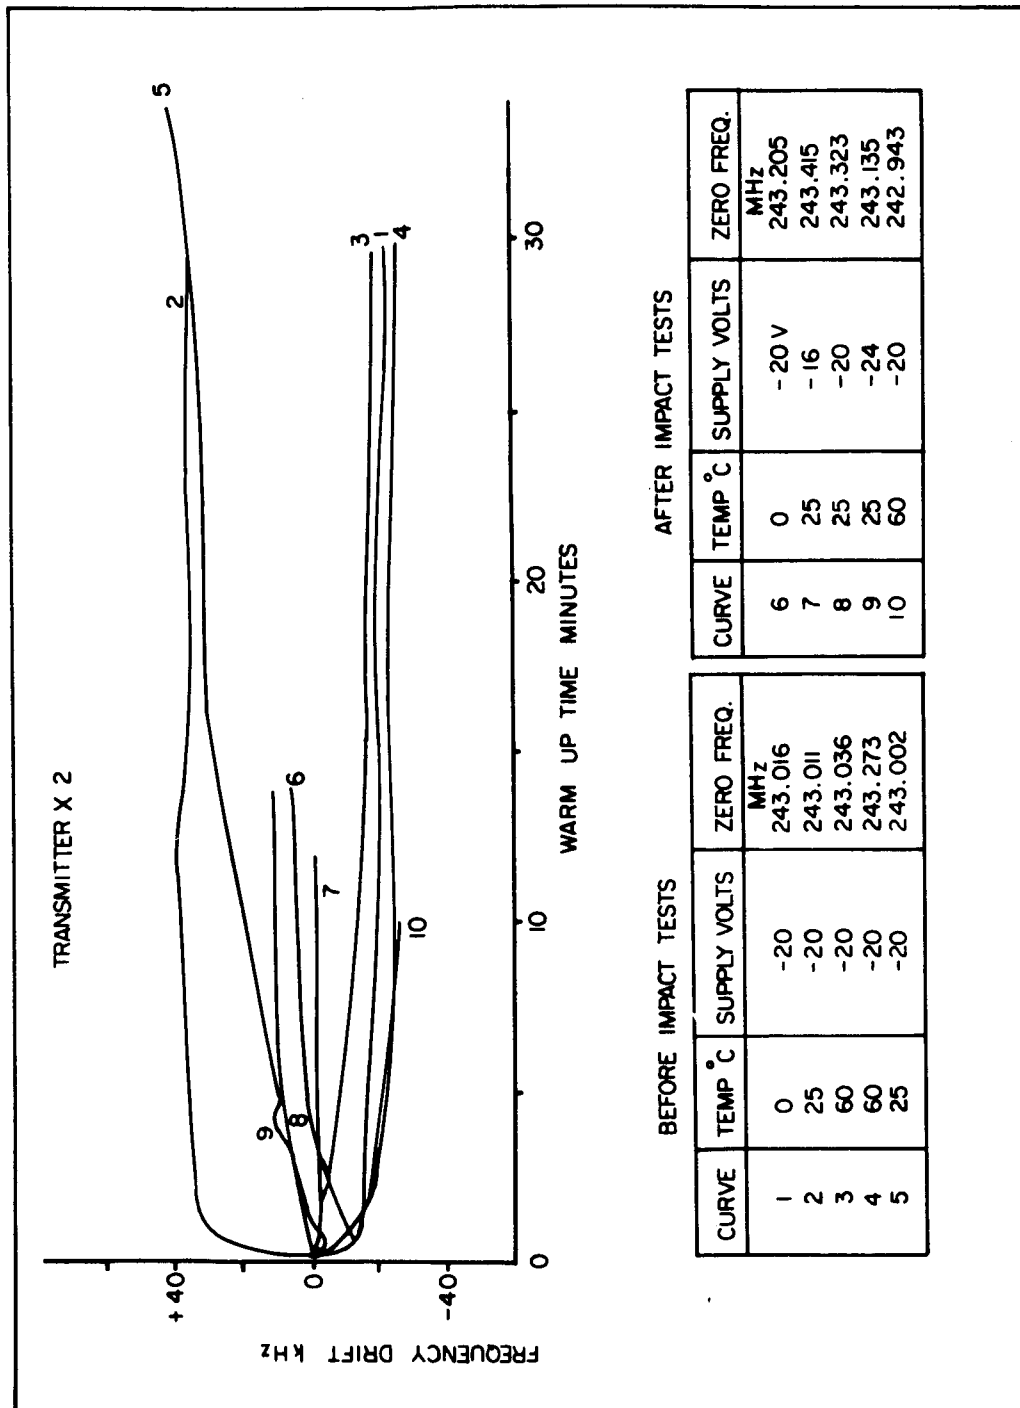
Figure 30. Transmitter X2 Warm Up Time and Short Term Stability

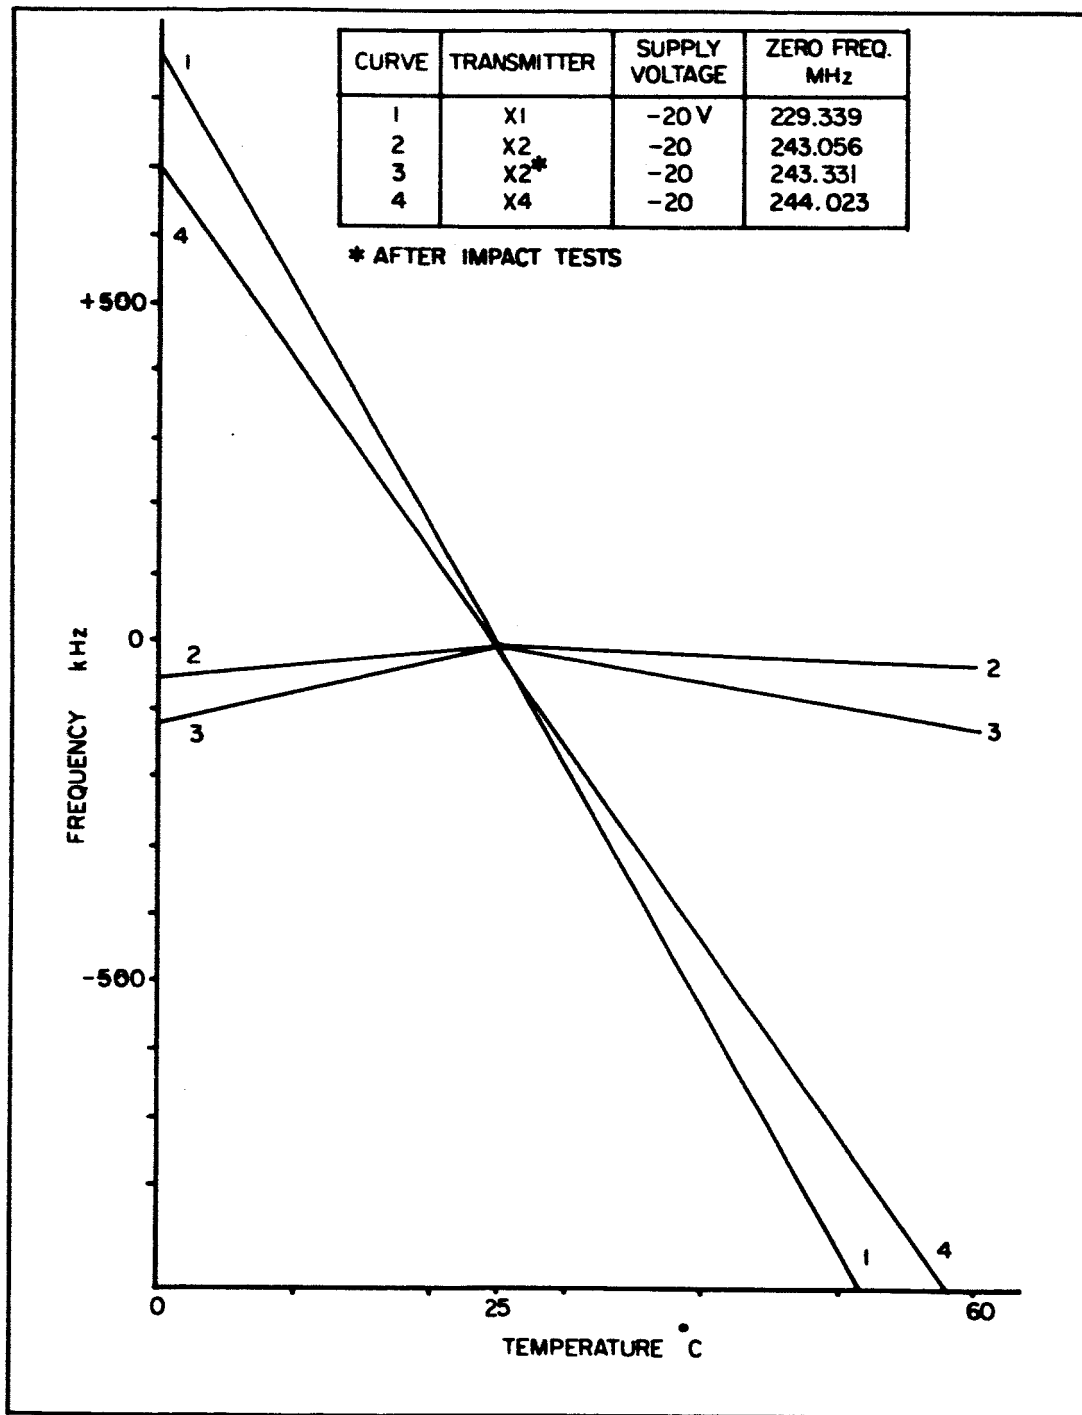
Figure 31. Frequency versus Case Temperature for the Final Phase II Transmitters

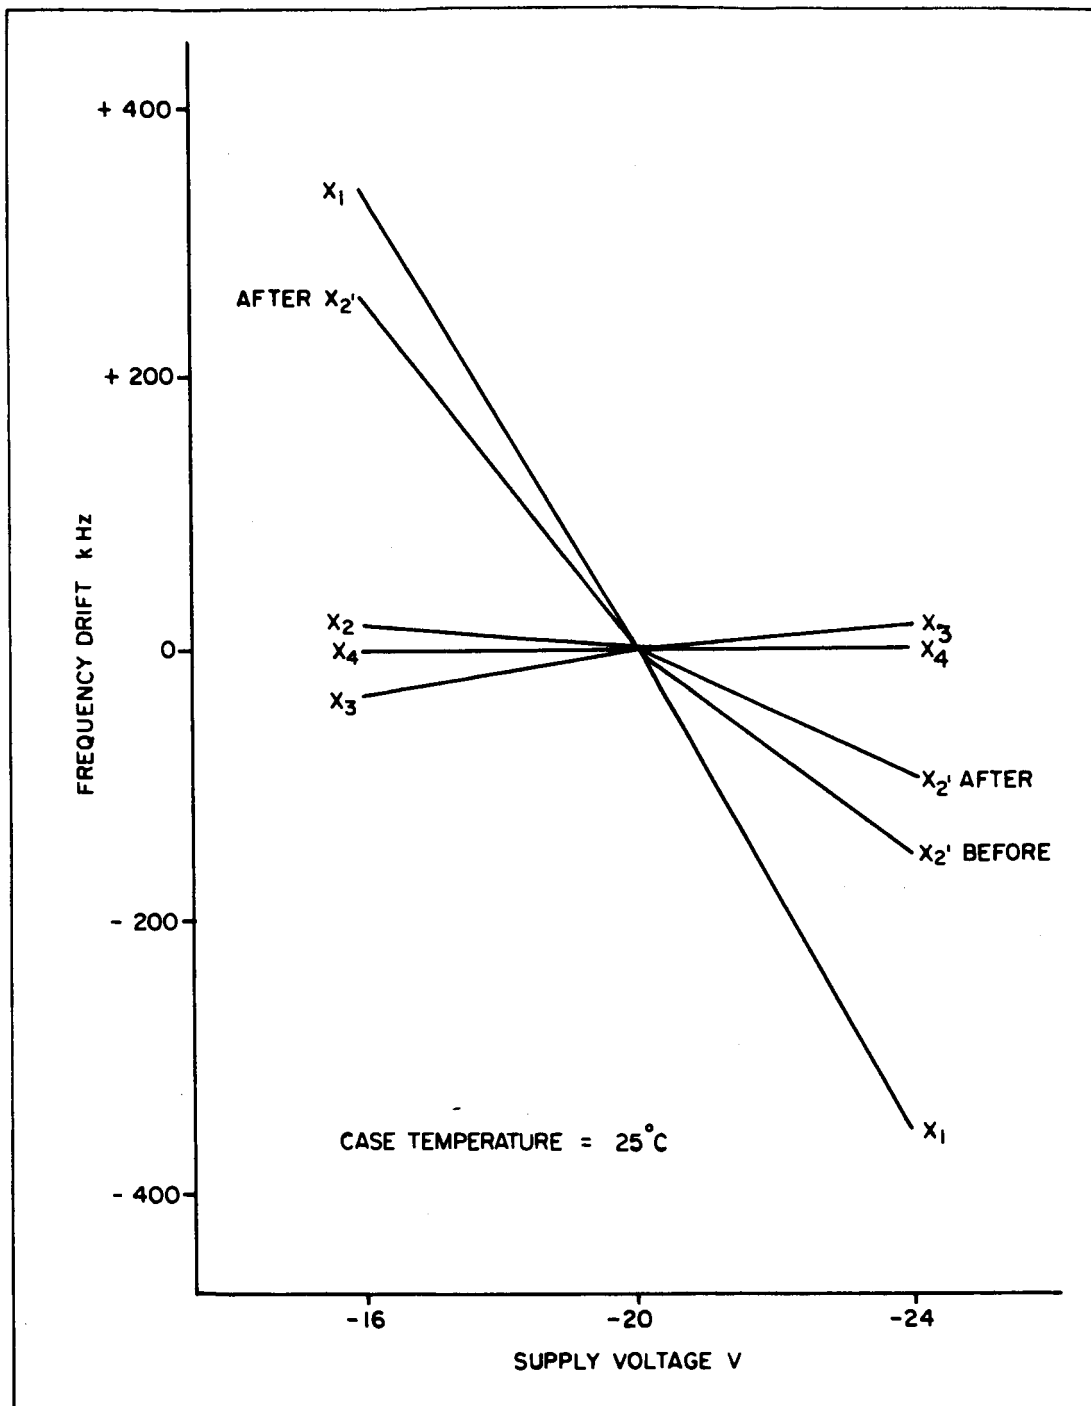
Figure 32. Frequency versus Supply Voltage for the Final Phase II Transmitters
